CENTRAL BEDFORDSHIRE BUS SERVICE INFORMATION – AREA 3: ARLESEY, SHEFFORD & CLOPHILL DISTRICTS

This section describes a survey of bus stop infrastructure in that part of Central Bedfordshire shown above and presents an evidence-based analysis to inform responsible authorities, operators and other interested parties.

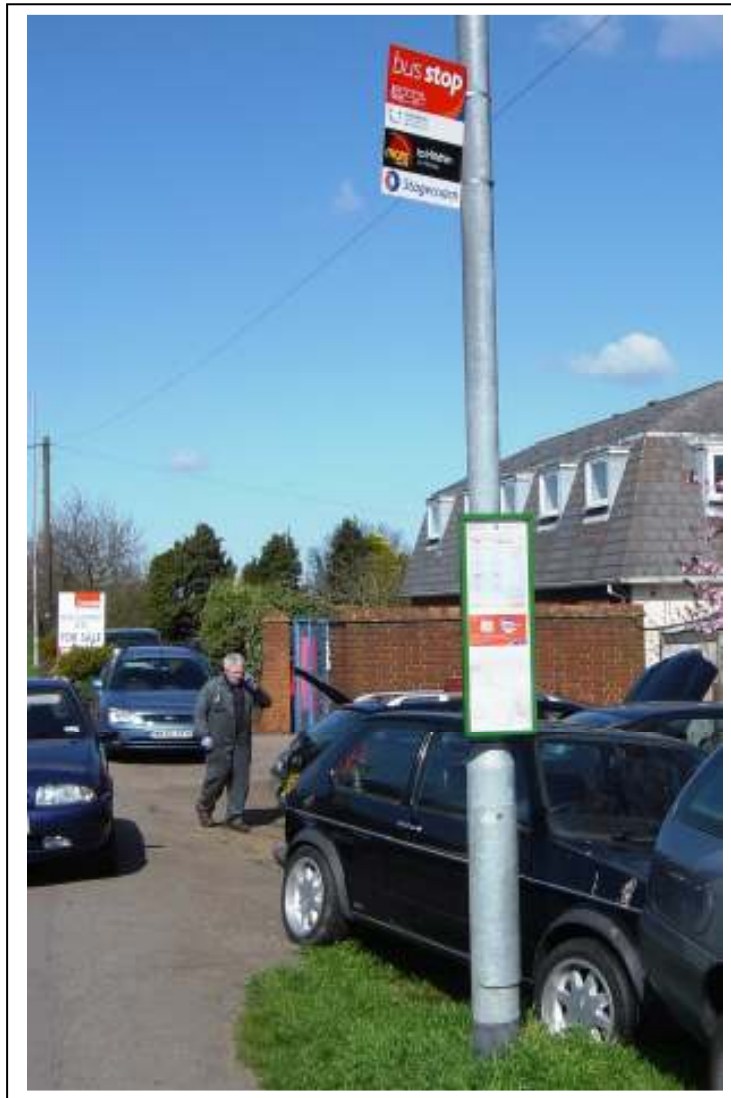
Figure 1 – stop ahlagmwt

In a small number of cases the published information on the siting of stops is unhelpful or misleading and some stops are not conveniently located for intending passengers. On the 200 route the bus does not stop at Campton, Rectory Road opp because it is making a right turn at that point. The western terminal point of service 90 is Henlow, The Crown o/s. In fact the bus turns and waits in Arlesey Road which location is out of view of the designated bus stop. These local anomalies are not helpful for occasional users or passengers who may be unfamiliar with such deviations. A particularly badly sited stop is in Henlow – Clifton (sic), Manor Road opp, where the stop is located in front of a motor vehicle repair workshop – see Figure 1.

This is obviously such a poorly sited stop that the question must be asked – why has it not been relocated to a safer position?

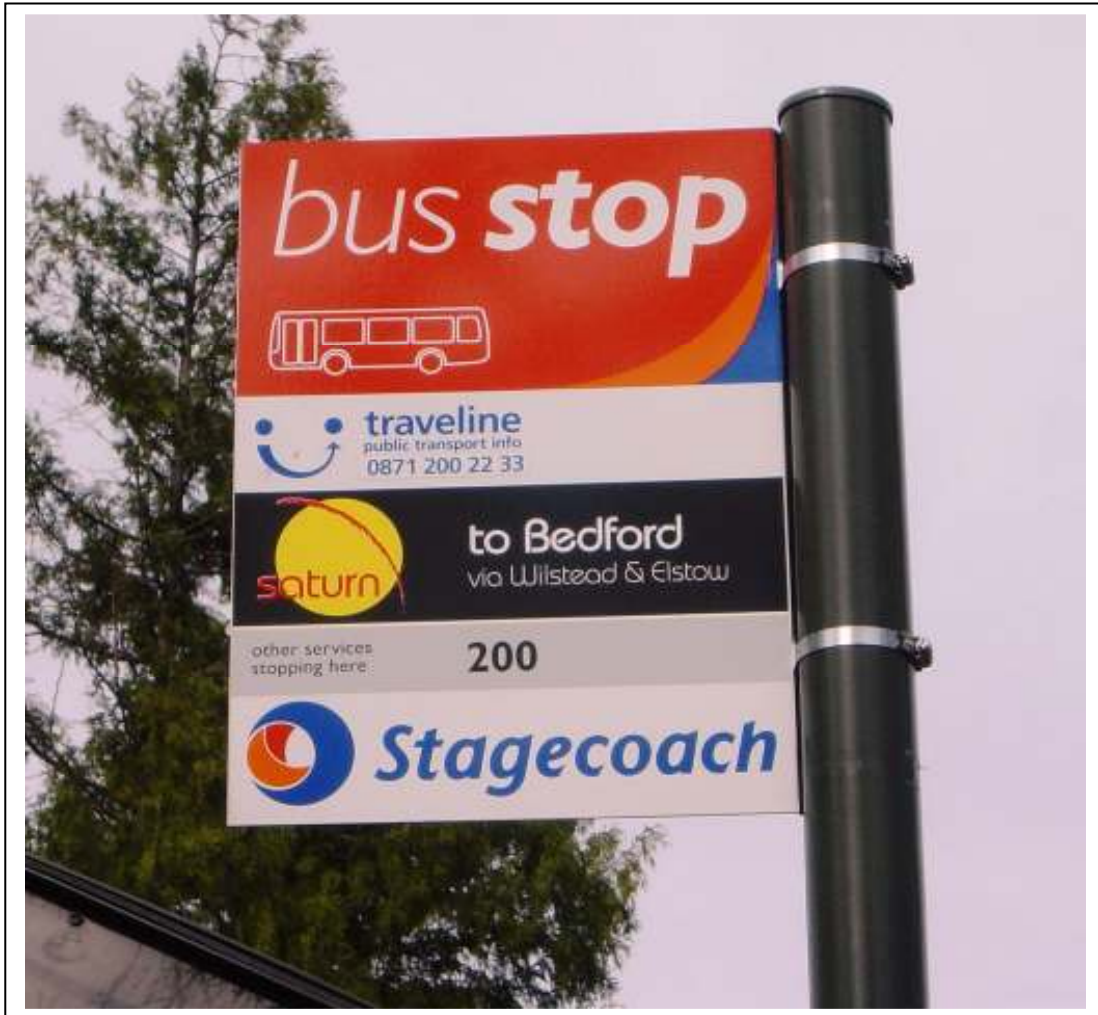
Figure 2 – stop ahlagmjg

In Central Bedfordshire it is not clear who 'owns' bus stop flags or who is responsible for their installation and upkeep. The general picture is unsatisfactory with many bus stops unidentified or with flags that carry incorrect information and exhibiting years of neglect. If the local authority at district or county level has a role in this matter it is clearly one that has been given little or no priority in recent times. Figure 2 below, shows the Stagecoach flag at stop ahlagmjg Clophill The

Green adj(S-side). Clear and informative and (very rarely) referring to a non-Stagecoach service – Grant Palmer 200.

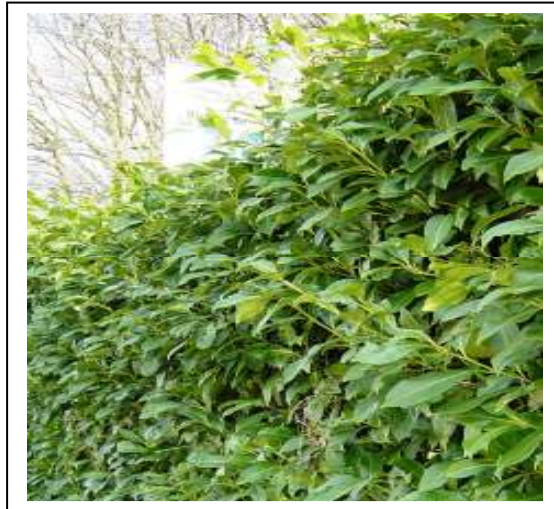
Figure 3 – stop ahlajapw

Figure 3 below – an all-too familiar example of neglect. The flag at stop ahlapw Broom The Woodlands adj. This is on route 200 operated by Grant Palmer. The well-camouflaged flag carries only the numbers 179 and 180, services withdrawn long ago.

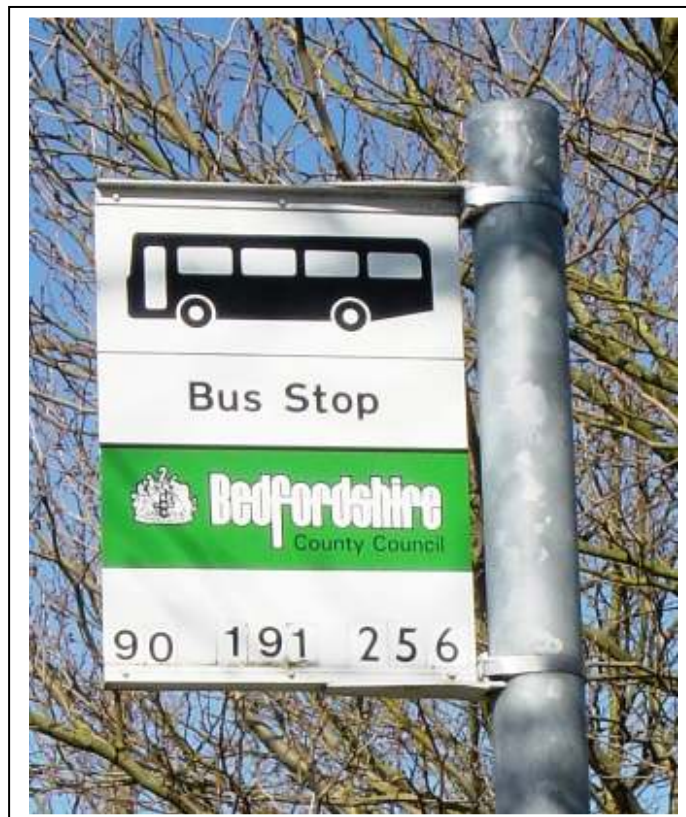
Figure 4 – stop ahlagtgw

Figure 4, below, shows the flag at Stotfold Larksfield Surgery o/s where 'ownership' would not appear to be in doubt. A patient leaving the Surgery and waiting for a 191 or 256 bus would have to be – patient. Very patient!

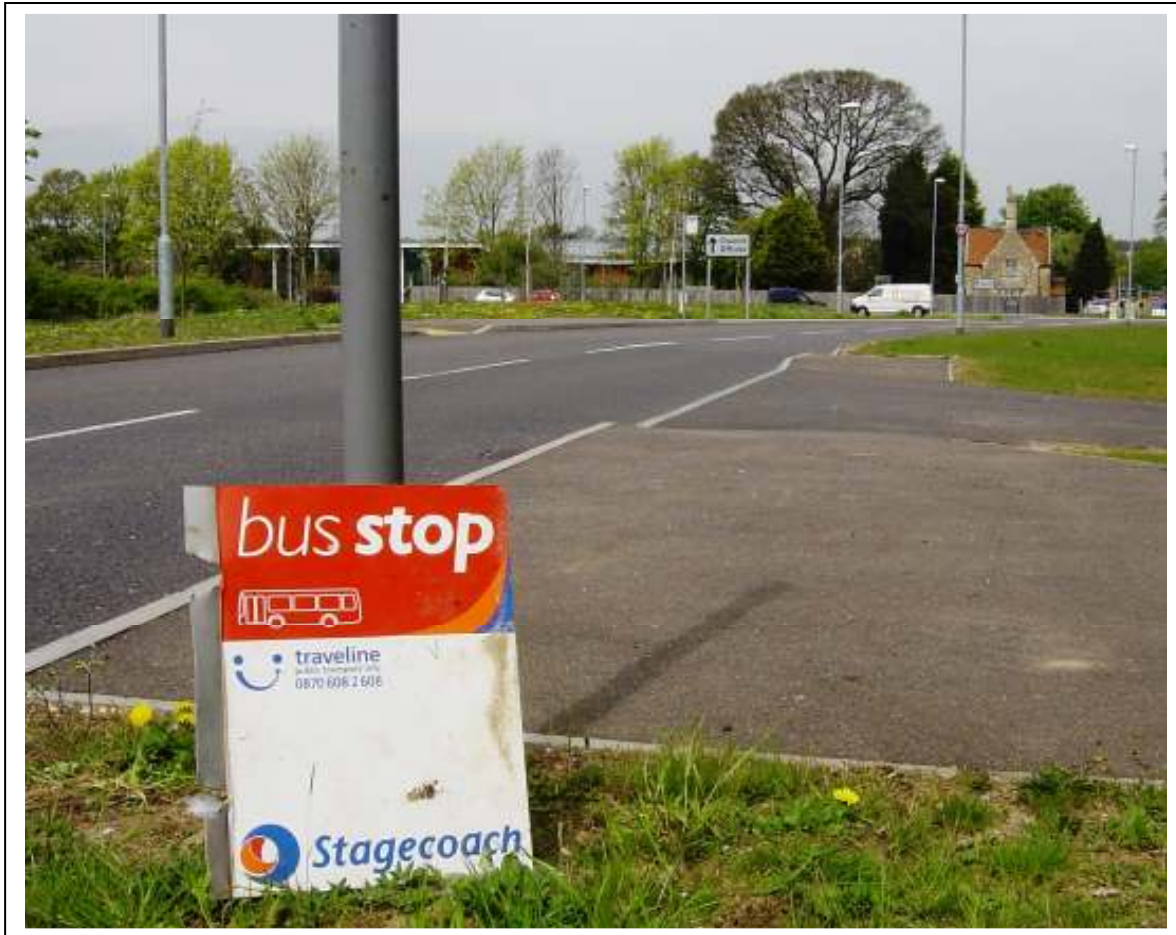
Figure 5, below, shows a (decapitated) flag which is demonstrably Stagecoach property on a route not currently operated by that company. (This stop is located not a million miles away from the offices of Central Bedfordshire Council.)

Of the 105 Stagecoach flags, 21 were on routes where they do not currently operate buses, as in Figure 5, above.

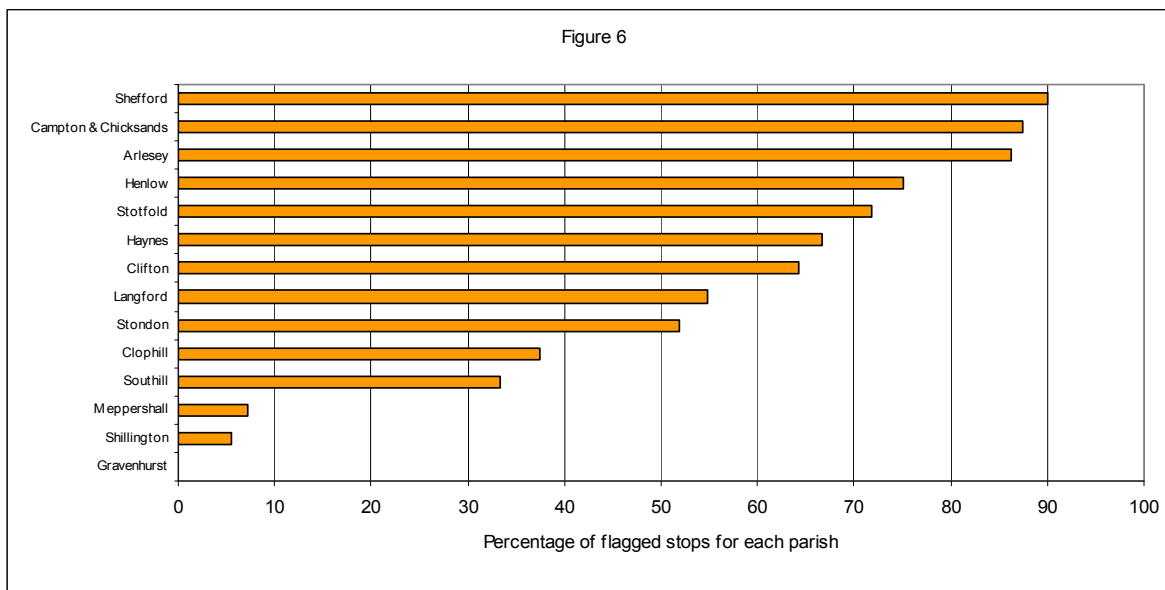
Figure 6, below, shows the proportion of bus stops with flags for each parish.

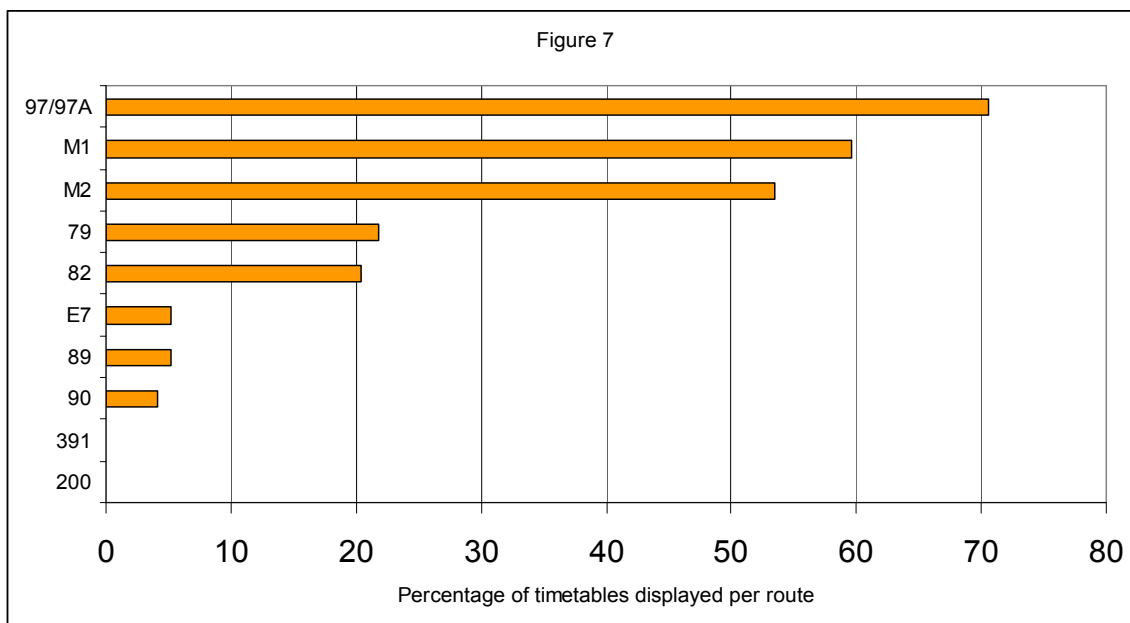
Figure 7, below, shows the proportion, as percentage, of stops with a current, legible, timetable for each service across the study area

It may be seen that the performance of Arriva and Stagecoach on routes 97/97A and M1/M2, respectively, is markedly superior to the routes operated wholly under local authority contract. Grant Palmer route 200, given its strategic cross-area service, is truly abysmal. These results should give the local authority funders of these services cause for concern? None of the timetables displayed fares information.

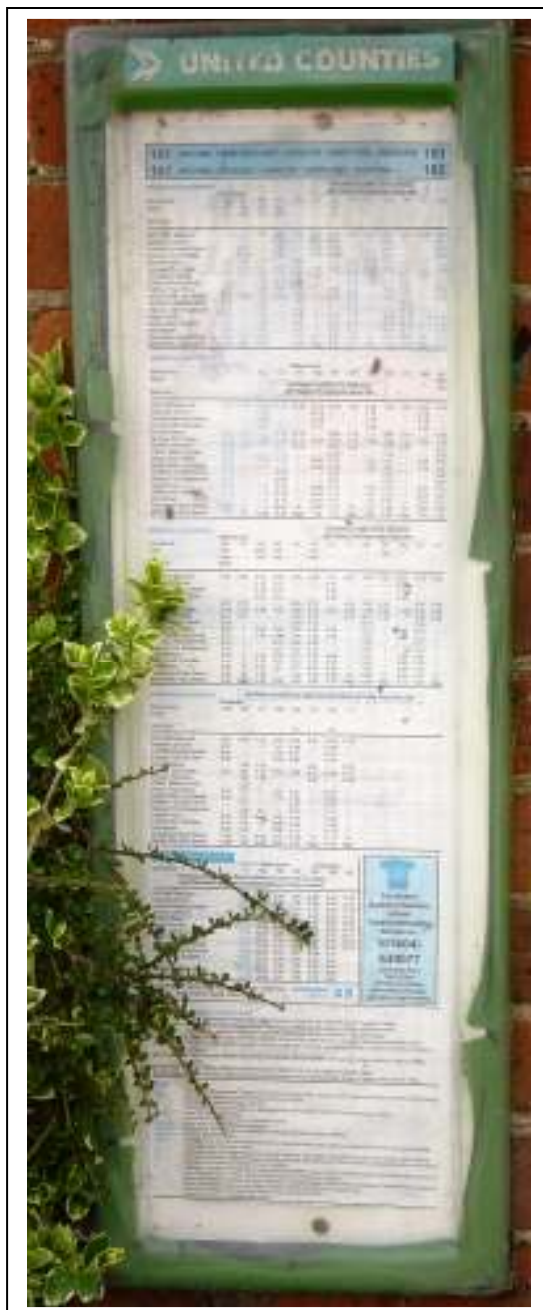
Figure 8, below. The timetable case mounted on the wall of the Greyhound Public House in Haynes. The adjacent unflagged bus stop is served by the M1 service; the timetable details services 181 and 182 which were withdrawn and replaced by M1 and M2 some years ago.

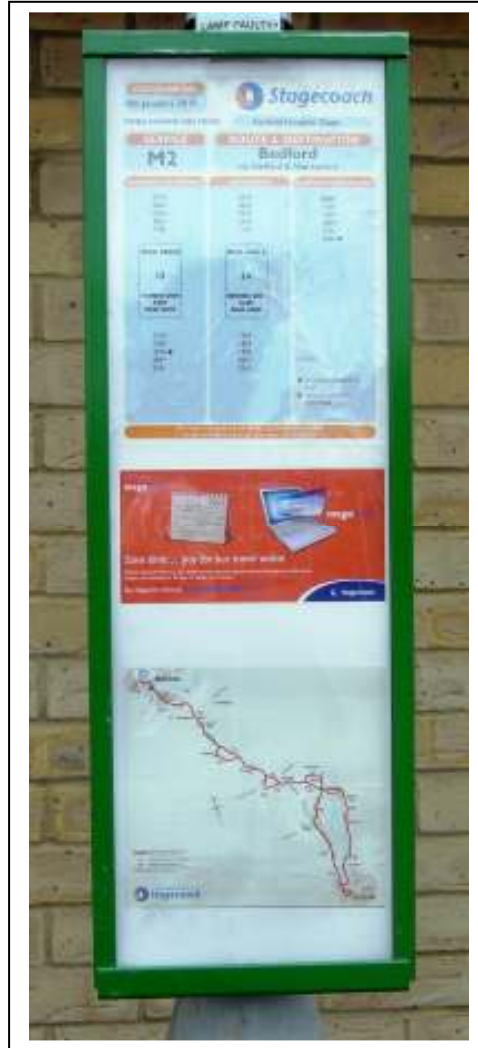
Figure 9, below. The Stagecoach timetable case located at Arlesey Community Centre opp, showing user-friendly M2 summary times to Bedford and with a clear route map. There is no reference to services 90 and E7 which also serve this route. If Stagecoach provide and maintain the case should they be expected to incorporate timetable information for overlapping and competing (?) services provided by other operators receiving support from public funds?

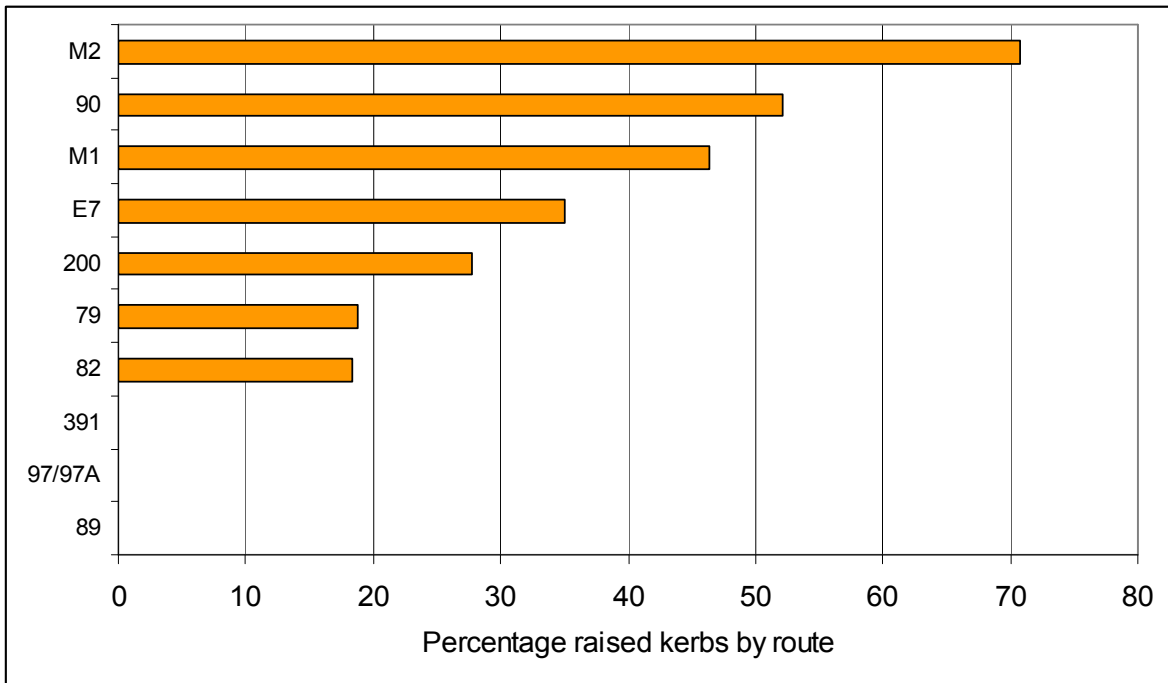
Figure 10, below shows the proportion of stops with raised kerbs for each route.

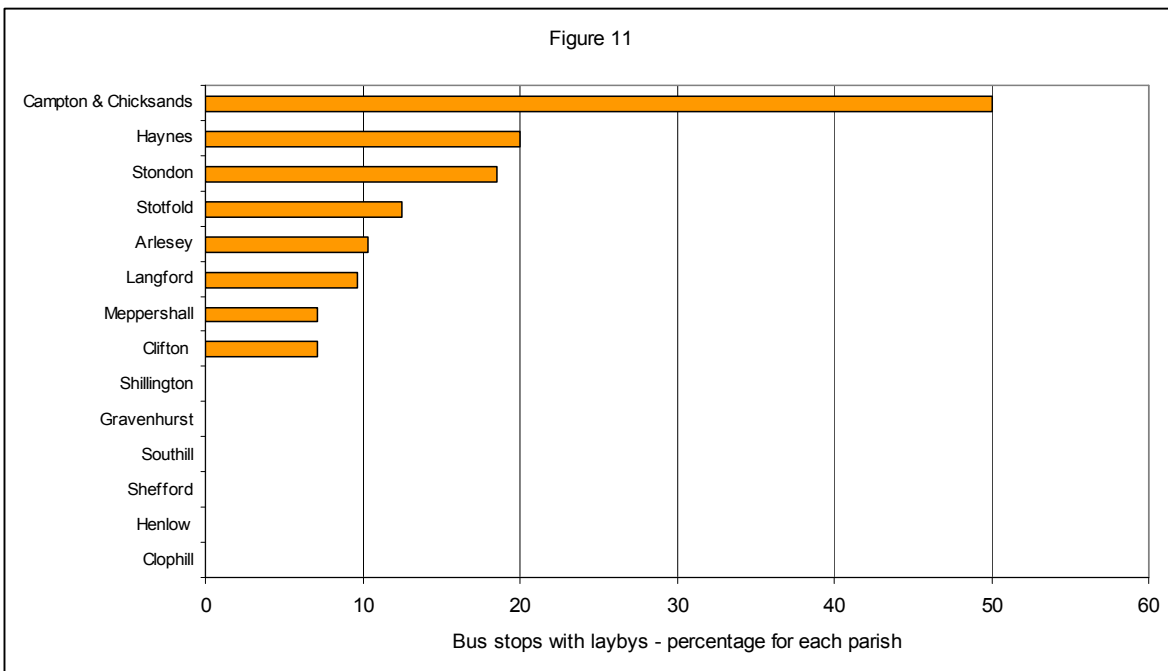
Figure 11, below, shows the proportion of stops with laybys for each parish. It is not clear what criteria are used in the provision and design of a layby for a bus stop. The provision of a layby must be a benefit for bus and for other drivers, especially where a bus turns and stands at the end of a route.

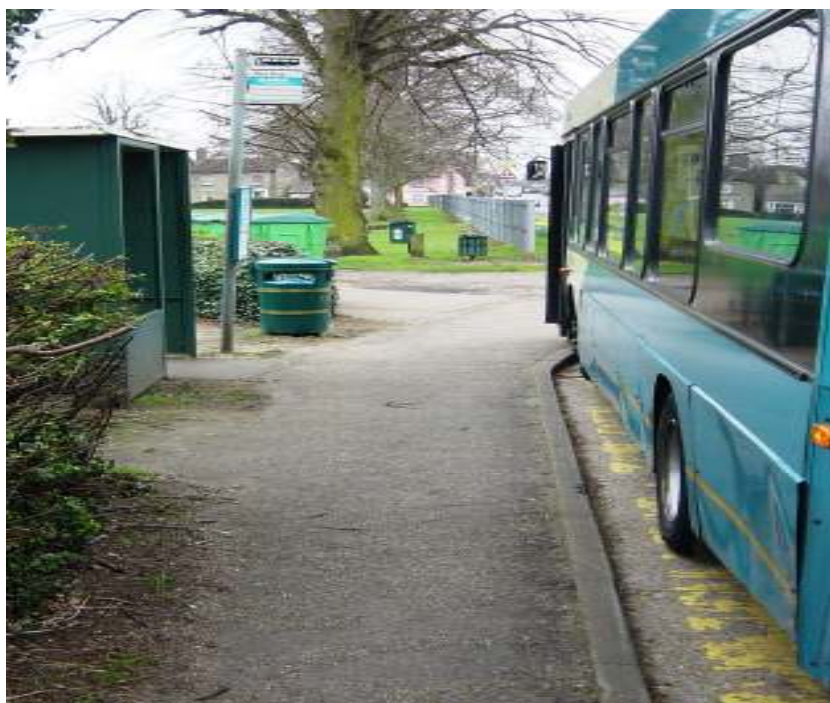
Figure 12, below, shows the end of Route 97 with a bus standing in the layby at Regent Court opp, Stotfold, a predominantly residential area with moderate traffic flows.

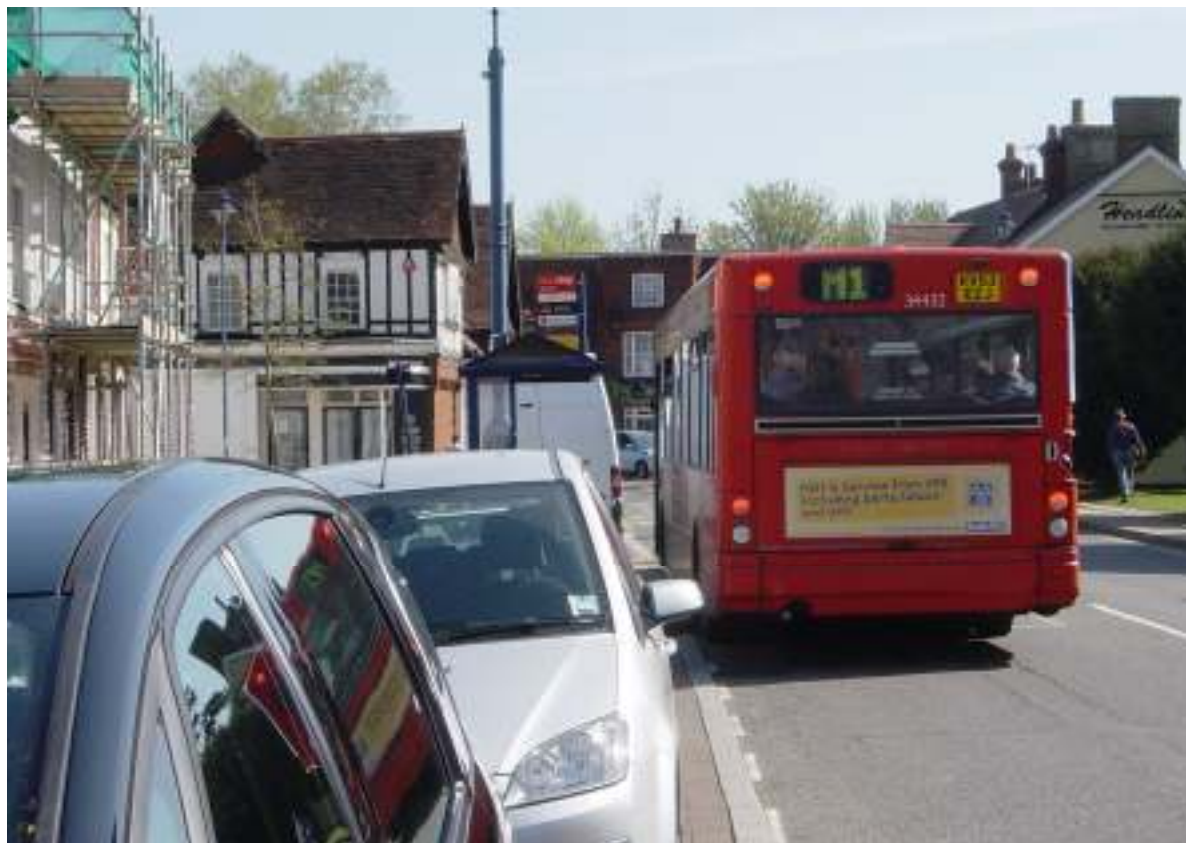
Figure 13, below, shows a particularly perverse example of road layout where adjacent laybys are provided for parked cars in Shefford High Street whilst buses are forced to block the carriageway in front of the traffic lights at a very busy junction. This layout did not happen by accident so the question is asked – what considerations were applied by the highways engineer when the Shefford High Street improvement scheme was implemented!

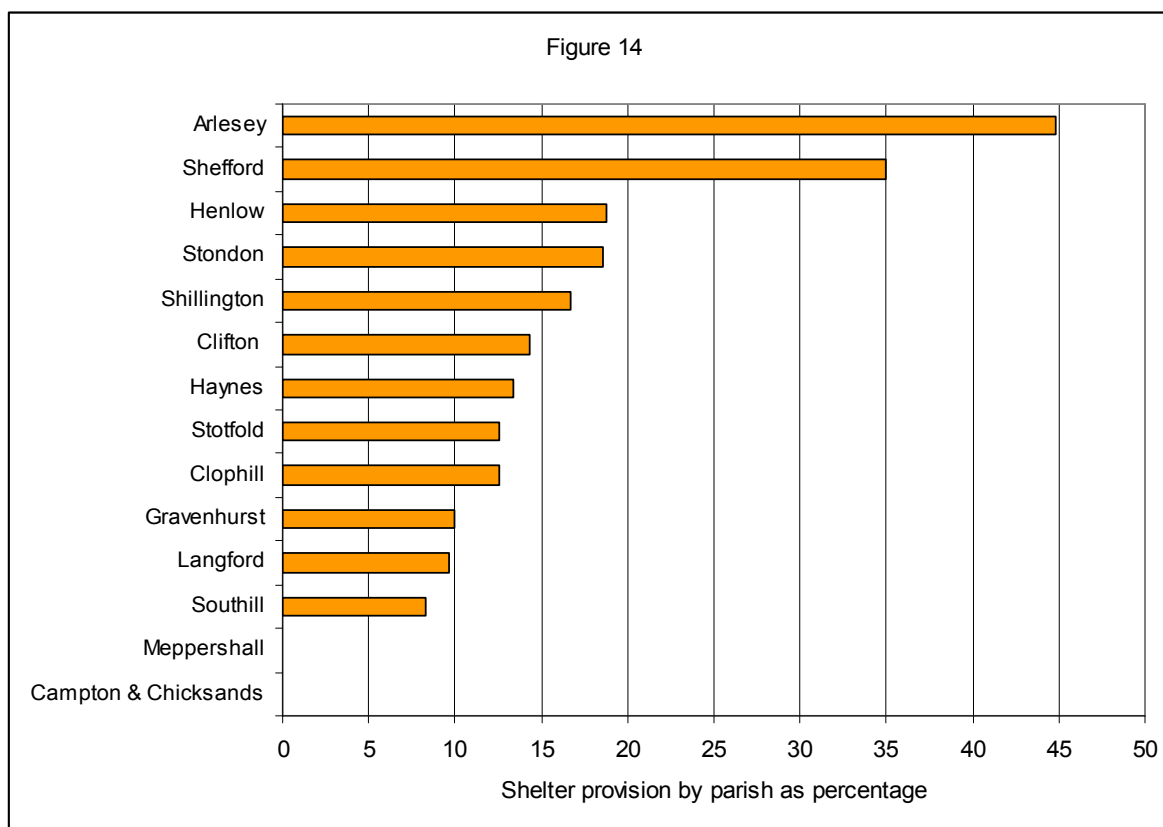
The responsibility for installing and maintaining bus shelters does not lie with the operator or with the district council or county council. In the first instance, bus shelters are the responsibility of the individual Parish/Town Council. Figure 14, below, shows the proportion of bus stops provided with shelters for each parish in the study area.

It may be seen that the different councils clearly have differing attitudes to the discharge of their responsibilities when it comes to the provision of shelters. Again it is not clear what criteria are used in deciding which bus stops justify the installation of a shelter. Recently a new shelter has been erected outside Samuel Whitbread School (in Clifton Parish) at the stop (ahlagmwa) for buses travelling towards Shefford. This stop is used by alighting passengers but rarely by intending passengers wishing to board a bus. Alighting passengers do not need a bus shelter! By comparison, the stop at Shefford Ivel Road opp (ahlagmtd) is used by relatively larger numbers of passengers who have visited the nearby Health Centre, yet no shelter is provided. It would be interesting to know what footfall figures for *boarding* passengers are used in deciding where and where not to provide shelters.

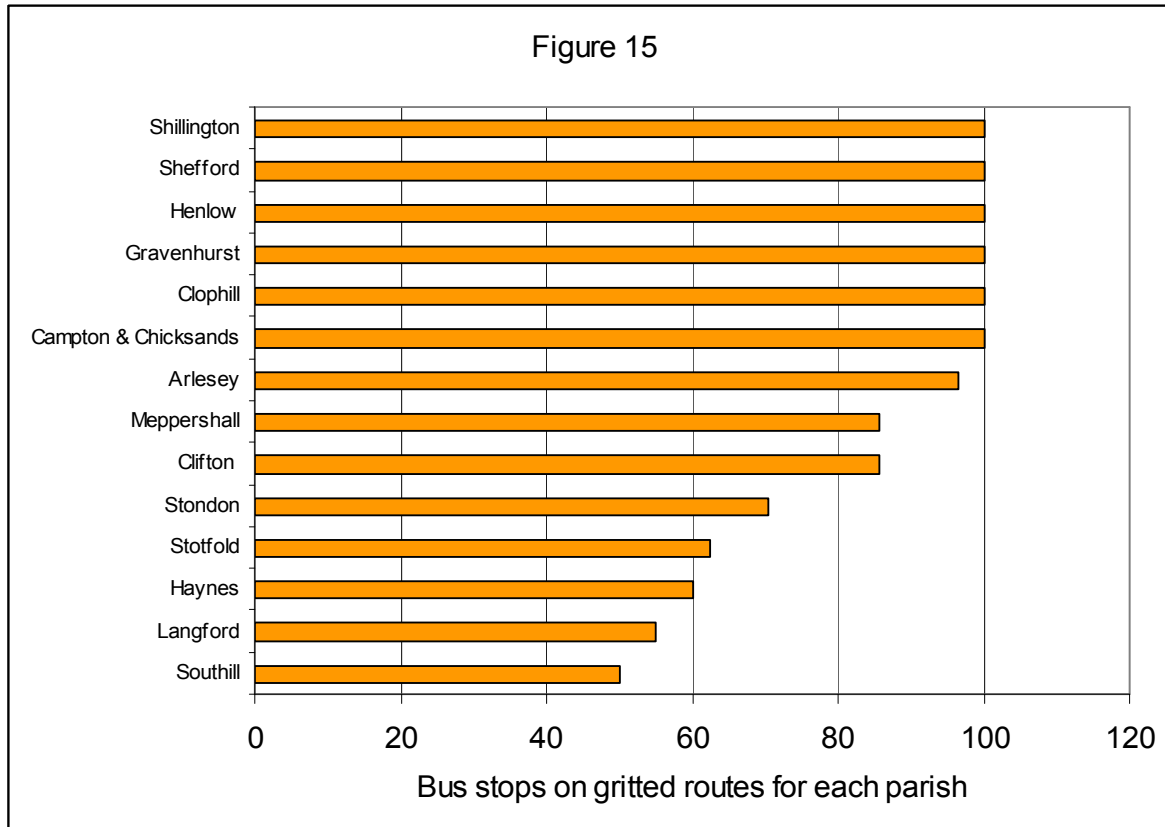
Figure 15, below, shows the proportion of stops located on treated routes for each parish. It is not just rural routes that are affected in bad weather (eg service M1 on Northwood End Road, Haynes) but some urban routes are not covered by the Central Bedfordshire Gritting Plan (eg 97/97A and

other services in Regent Street, Stotfold). It is suggested that all bus routes are given priority for coverage in the annual gritting plan. If this cannot be done then reasons should be provided by the highway authority and the relevant bus operators and parish councils consulted.

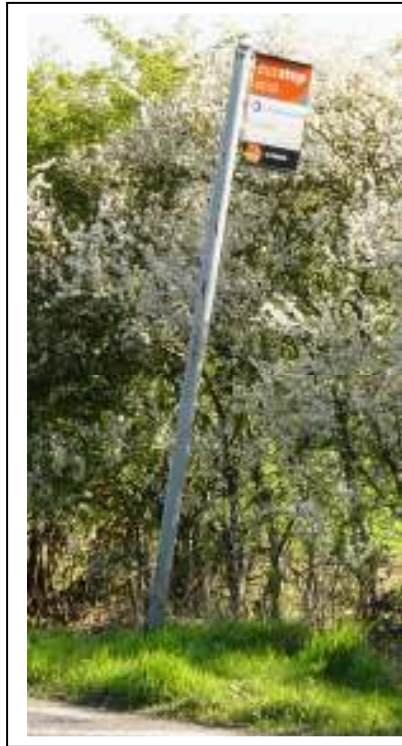
Figure 15 - ahlagtgp

Figures 15 and 16 show two consecutive stops on the same route. The first image shows stop ahlagtgp on route M2 with a Stagecoach flag. This is the last stop in Central Bedfordshire on the Arlesey-Ickleford road.

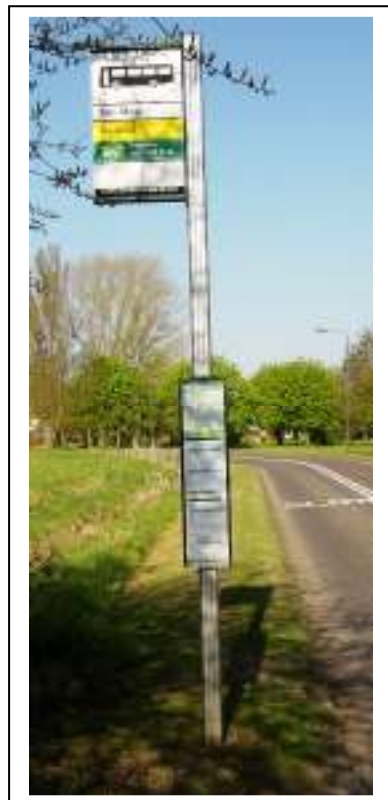
Figure 16 – hrtgjawm

The second image, Figure 16, above, shows the next stop on the same M2 route southbound from Arlesey towards Hitchin. This stop is located at Cadwell Green, just inside the Hertfordshire county boundary. The pole is vertical (unlike its drunken neighbour) and carries an Intalink flag and timetable case. The flag carries the name of the stop – ‘The Green’ – a practice found on virtually all Hertfordshire bus stop flags but conspicuously absent across Bedfordshire.

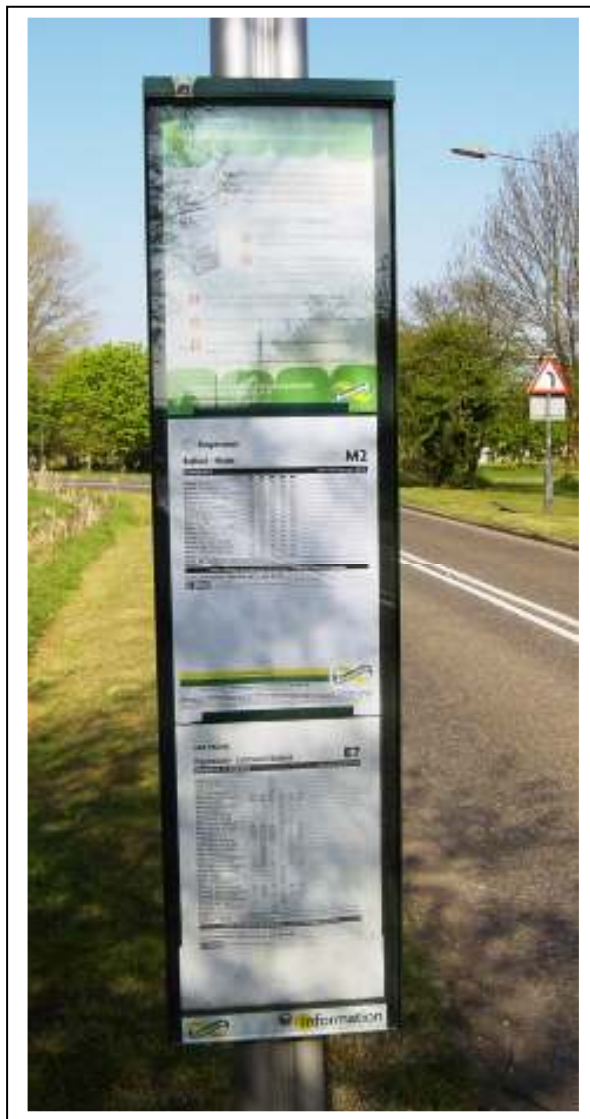
The timetable case (below, in close-up) is, like the pole and flag, owned by Intalink, and contains information on M2 and E7 services. The timetables are produced by Intalink, the Hertfordshire public transport partnership, to a common standard and not by the individual operators. It also contains an advertisement detailing the NextBuses.mobi service which delivers live bus times to an internet-enabled mobile phone. The contrast between this rural and fairly isolated stop with the general, poor, standard across Central Bedfordshire could not be greater.
